*Early Domestic Architecture  
of Connecticut*

*By J. Frederick Kelly*

J. Frederick Kelly, A.I.A.

New Haven: Yale University Press

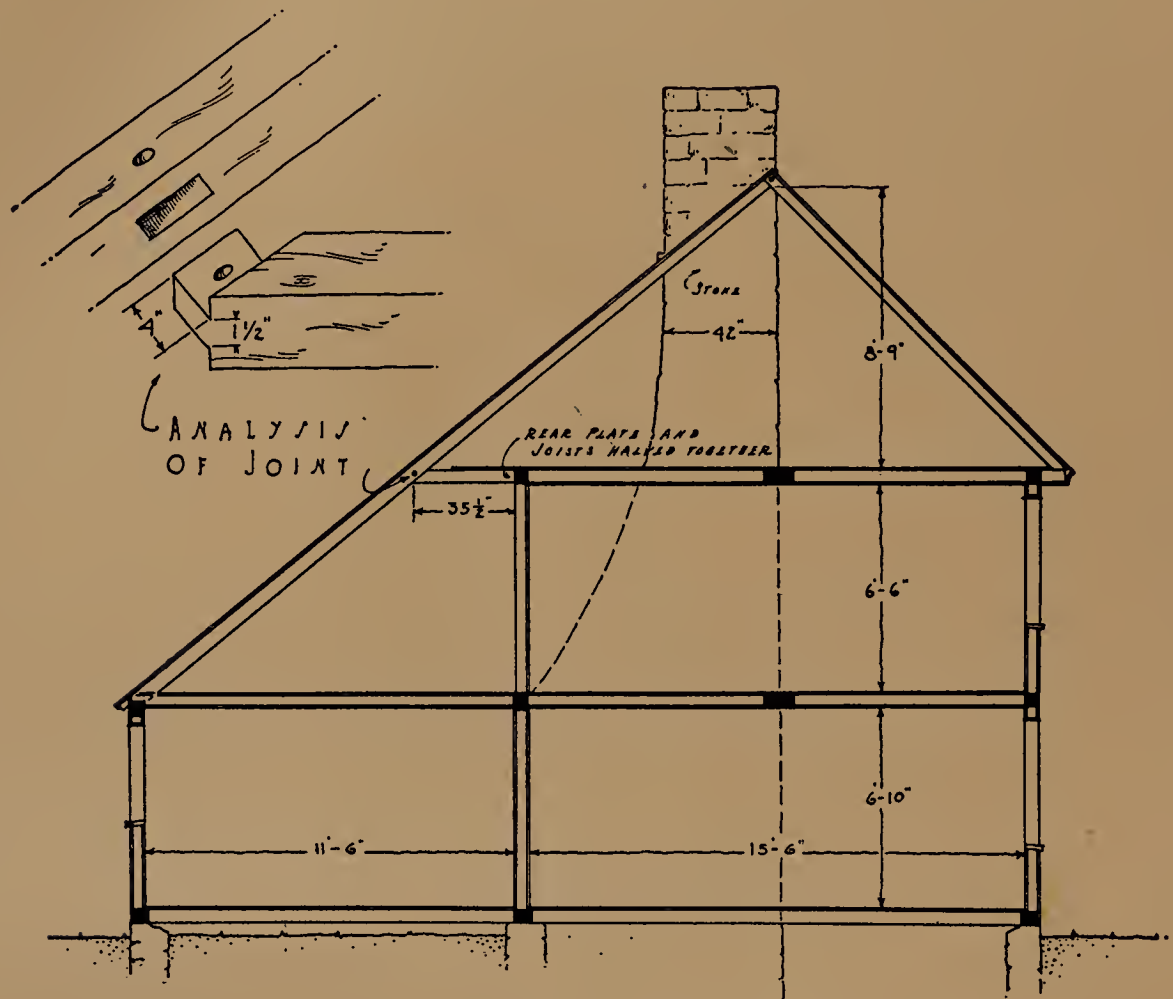
plastered ceiling of the second story, as do those in the Hall house. This method of cantilevered girt construction exists in the Benjamin house, Milford (*circa* 1750). I have not found it in any other localities than those mentioned. Although it may have been utilized to a considerable extent in those places, it cannot properly be called, on the whole, a common form of construction.

• CROSS SECTION •

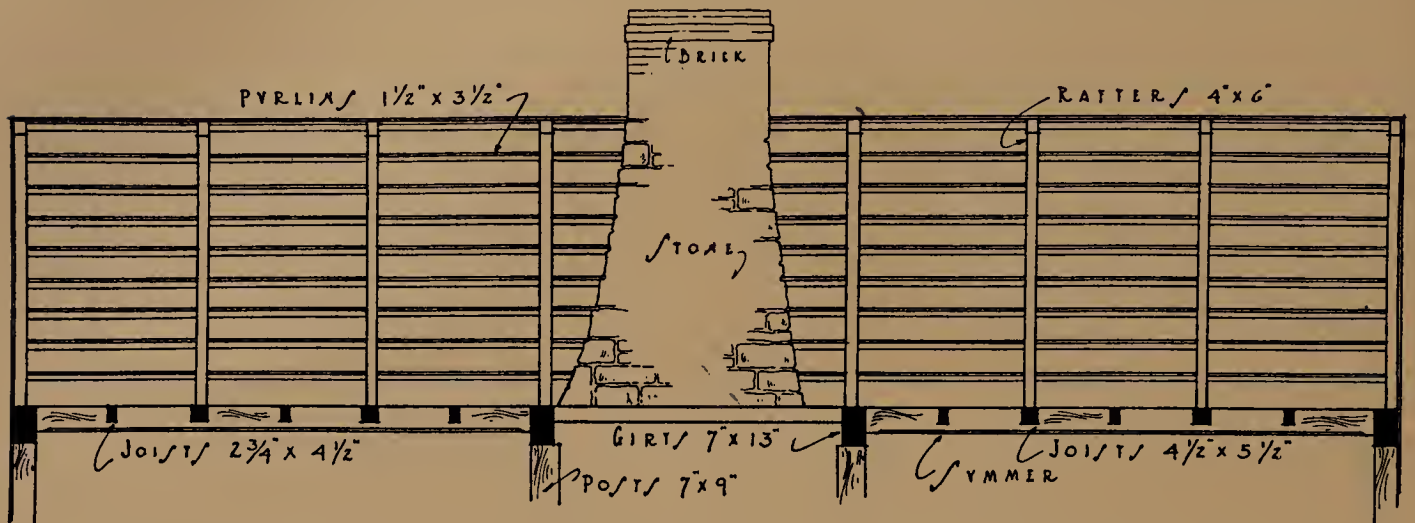
FIGURE 67.

SECTION SHOWING ATTIC FRAMING  
ALLEN SMITH HOUSE - MILFORD

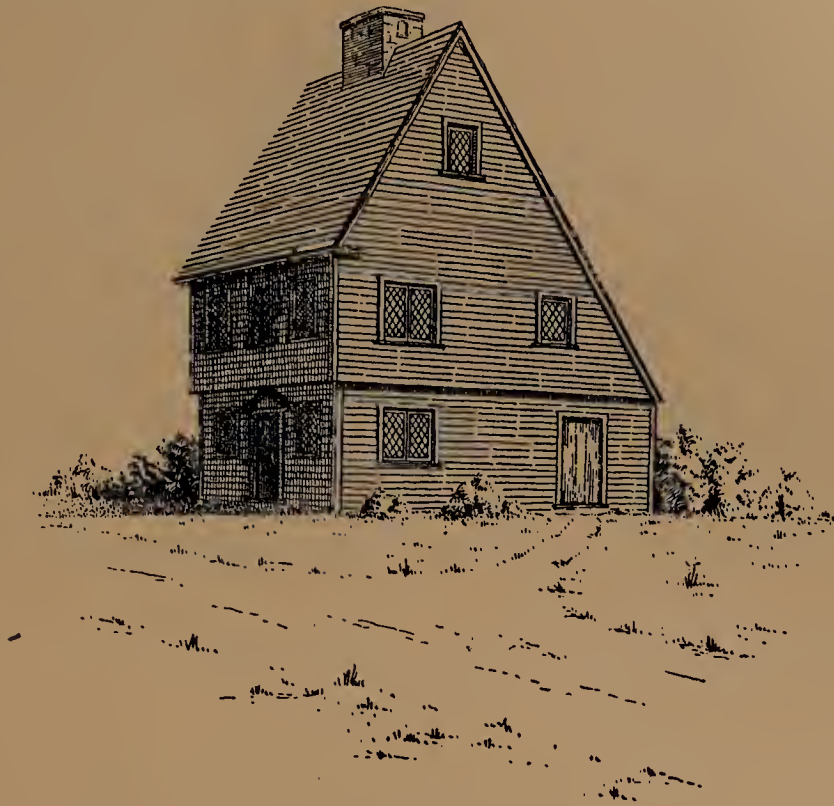
FIGURE 68.

The drawing of the Governor Treat house, Milford, copied from one of Lambert's illustrations, shows a roof of extremely steep pitch. (Figure 68.) Even making allowance for exaggeration or faulty draftsmanship, the angle of the roof must have been very sharp. The Hempstead house of New London, the western part of which was built in 1643, is one of the earliest wooden houses standing to-day in the state of Connecticut. The pitch of the original roof of this house, as may be seen in the attic, where the old gable rafters are still in place, was fifteen inches to the foot, a very steep pitch. (Figure 69.) Mr. Ralph D. Smith, in information furnished Mr. Palfrey for his history, states that

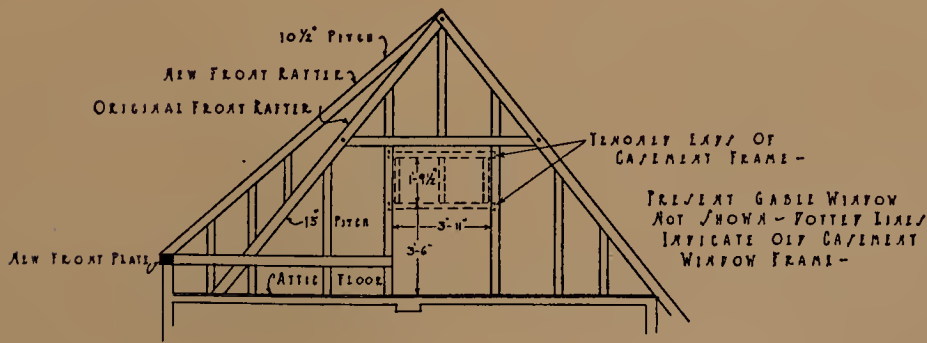
• WEST END GABLE •

∩ HAMPSTEAD HOUSE - NEW LONDON ∩

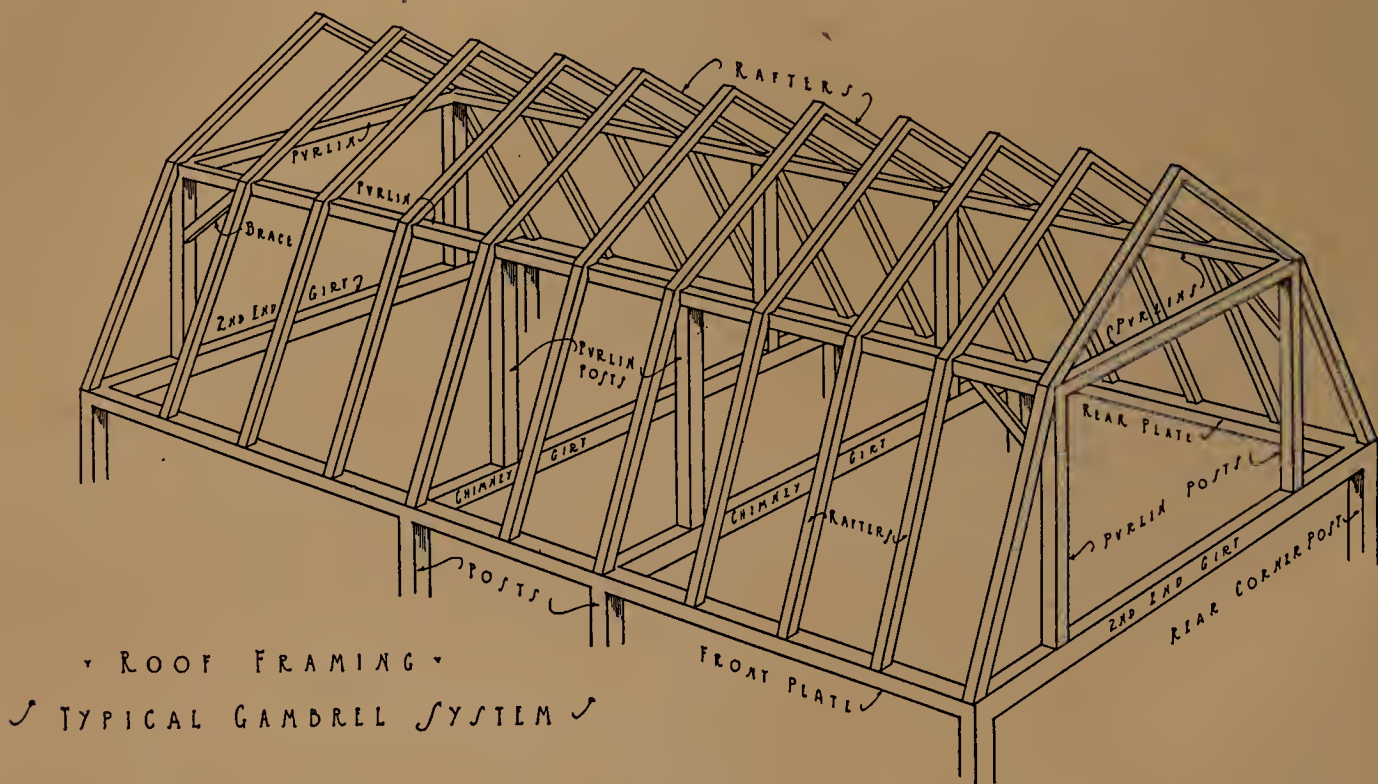
FIGURE 70.

The gambrel frame varies but little in its details; the main members of construction are always the same. A typical system of gambrel construction is shown in Figure 70. From this diagram it will be seen that a heavy horizontal purlin, supported by posts which have a footing upon the second-story girts below, is placed at the intersection of the two roof pitches, to provide a bearing for the common rafters of the roof. These two purlins—

for there is one for each side of the roof—are usually secured by diagonal braces down to the posts which carry them, and by additional horizontal cross ties between corresponding front and rear posts.

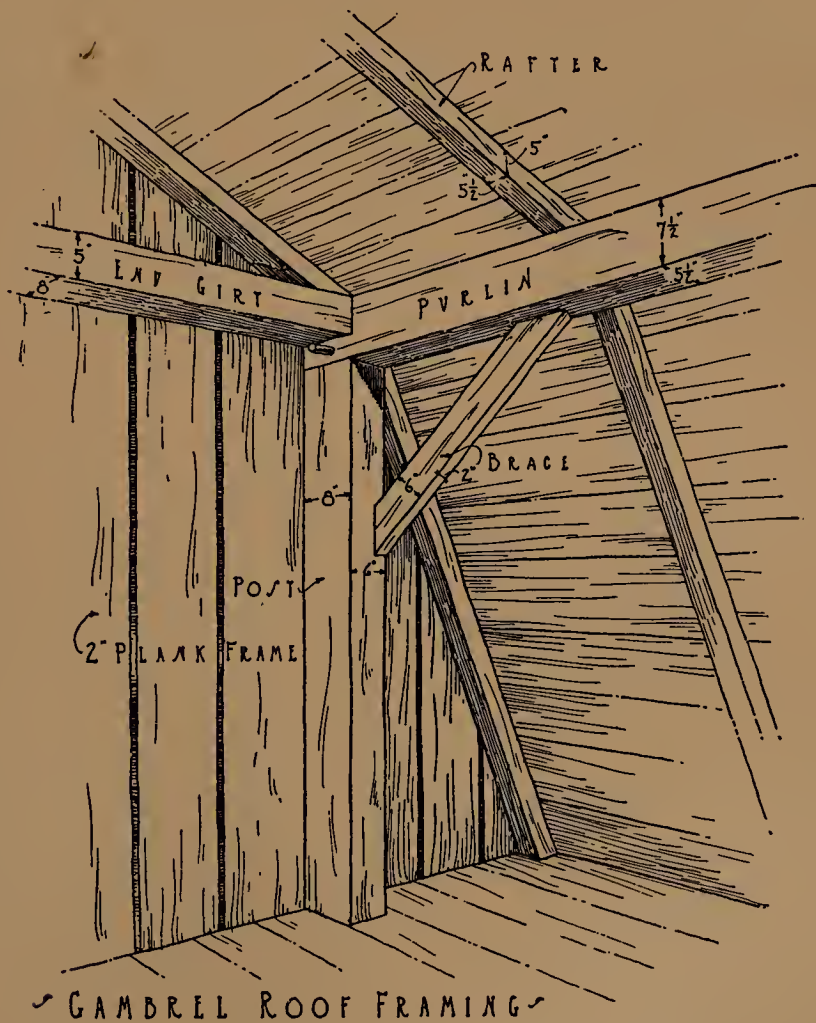
FIGURE 71.

The roof of the Glebe house, Woodbury (*circa* 1753), is an interesting combination of the gambrel and the lean-to; the first pitch of the rear roof is extended down over the rear part of the house in the customary lean-to fashion. (Plate VI.)

◊ GLEBE HOUSE-WOODBURY ◊

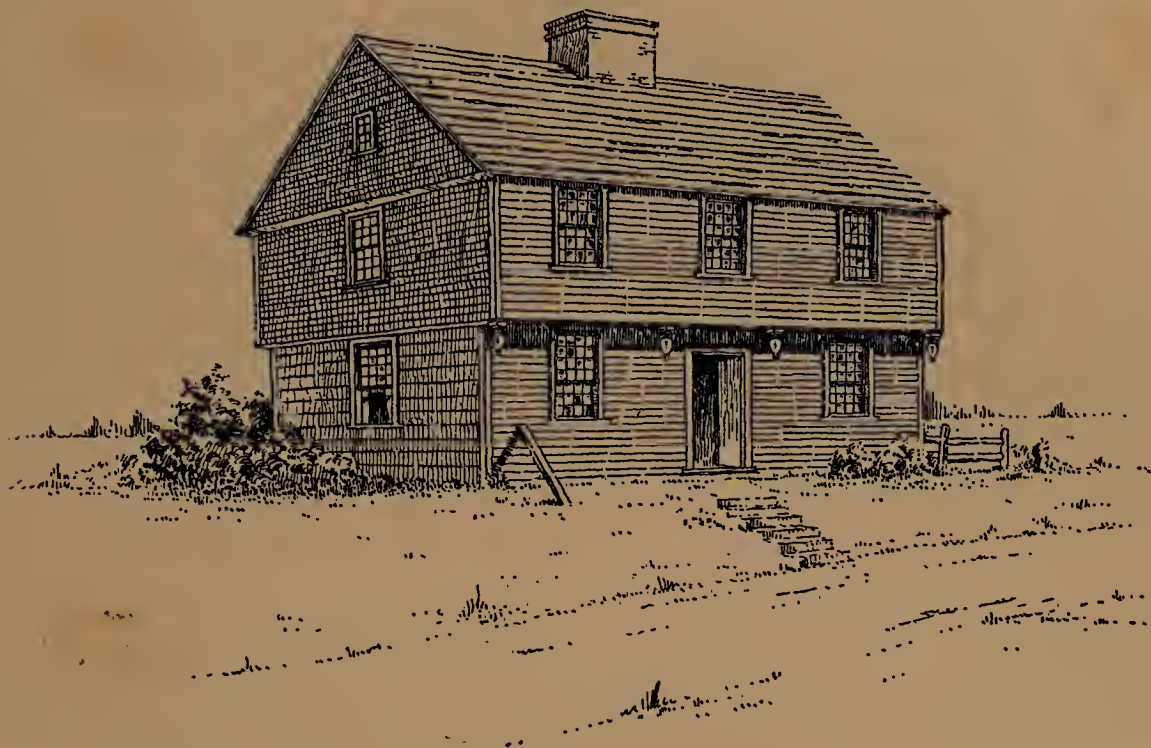
FIGURE 72.

story posts. There were thus four drops across the front of the house. (Figure 72.) These drops, which were hewn or worked out of the lower ends of the posts, of which they were an integral part, were of pleasing contour, and gave a decidedly piquant charm to the houses they adorned. Aside from the one example of chamfered girts, to be seen on the front of the Hyland-Wildman house, their use is the only instance of decorative treatment of structural forms in connection with the Connecticut house exterior.

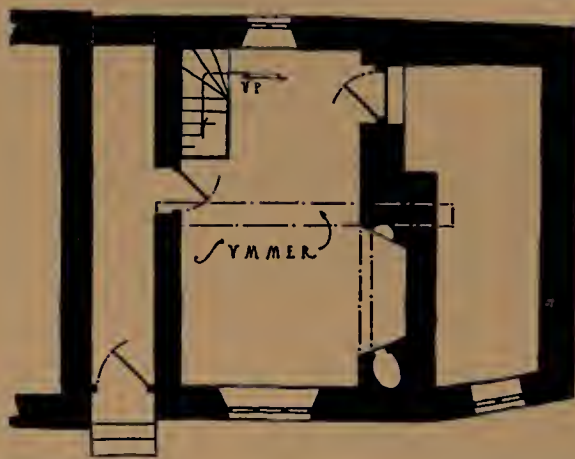
FIGURE 73.

The summer is an old form of construction, and, like its English prototype, almost invariably extended from the outside wall across the room to the chimney. It is a regular feature of English work of the period under discussion. The cottage plan shown in Figure 73 indicates it in its customary position.

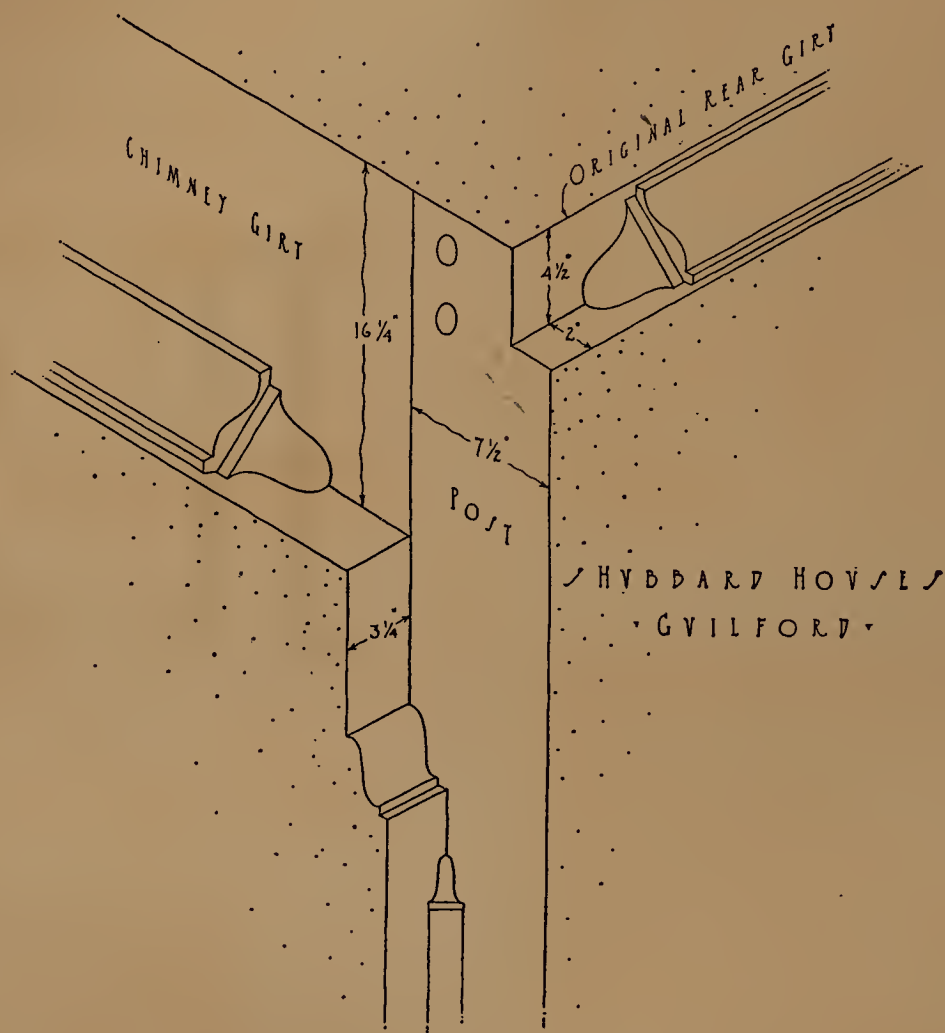
FIGURE 74.

The chamfering is a characteristic treatment of the summer. It varies in different examples from a simple bevelling to a handsomely moulded finish, such as is to be seen in the Hubbard house in Guilford (1717). (Figure 74.) Very curiously, the chamfering of the summer beams of the Hubbard house is almost identical in section with that of the first-story front girts of the Hyland-Wildman house (*circa* 1660) in the same town, as may be seen from the exterior. (Plate X.) It is quite probable that both are the handiwork of the same craftsman. Such elaborate chamfering as this example exhibits is, however, unique. The boldness of its section makes it of exceptional interest. When the chamfer was of simpler form, much pleasing ingenuity was exercised in the manner of its termination at either end. The terminations or "chamfer stops," as they were commonly styled, were for the purpose of preventing the chamfering from running into the girts into which the summer was dovetailed at either end. (Figure 75.)

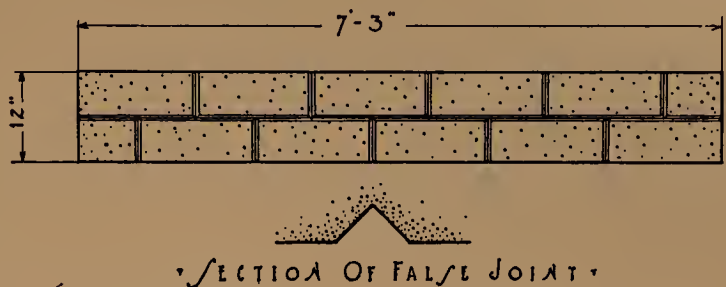
FIGURE 77.

From Revolutionary times onward the underpinning received much attention. In most of the houses it was well and carefully built, and material for its construction was often brought from considerable distances. A typical stone from the underpinning of the Orton house, built in Farmington about 1698, and now demolished, is shown in Figure 77. The material is a variety of conglomerate sandstone, and its measurements are 7 feet 3 inches in length by 1 foot in height. The exposed face of the stone has been cut with false joints of V-shaped section, which subdivide it into a number of rectangular blocks.

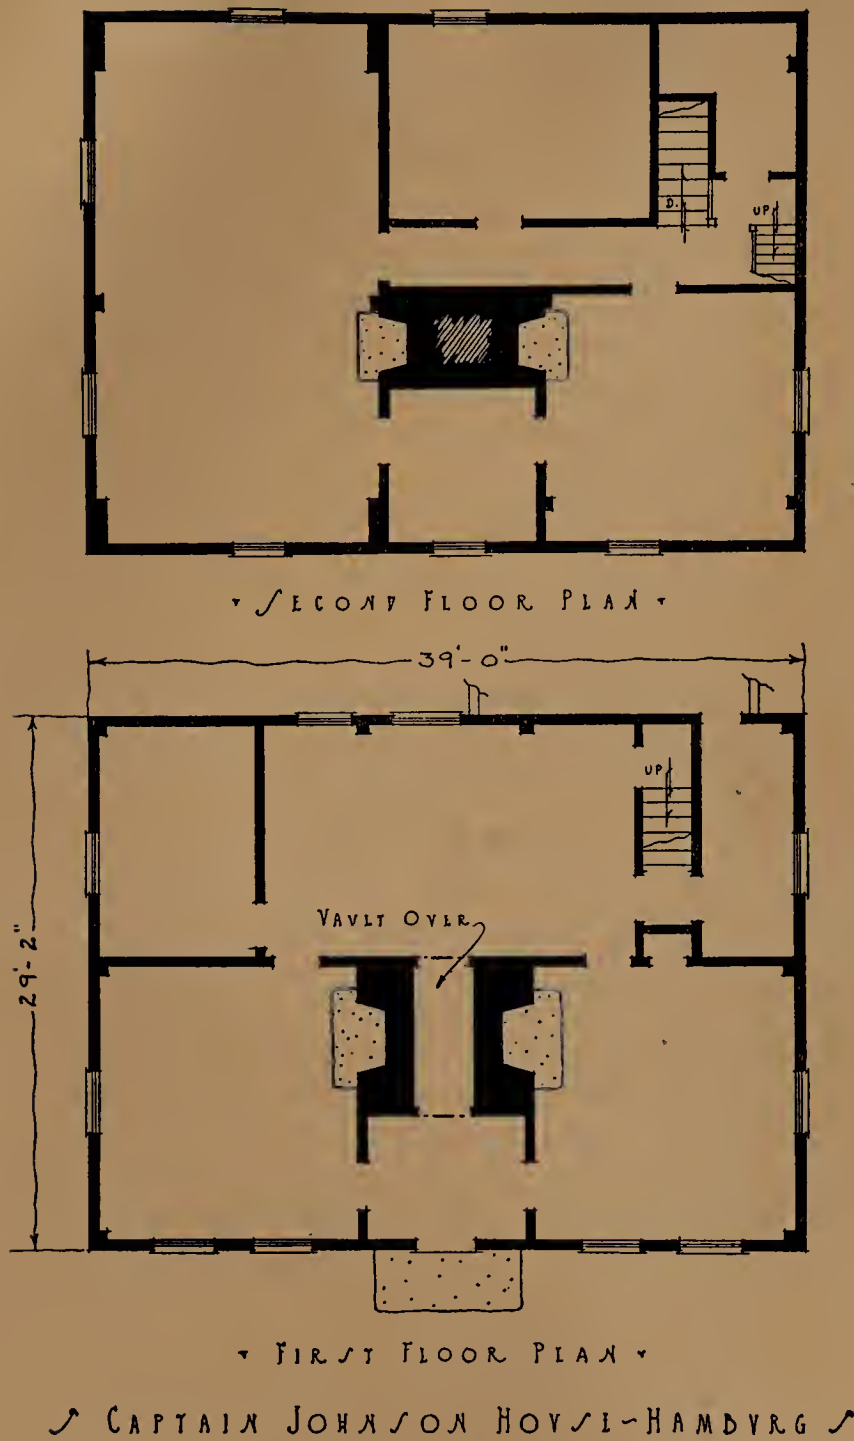
FIGURE 78.

vaulting existed in the Tuttle house in West Hartford (*circa* 1700) until recent years, and may still be seen in the Captain Johnson house in Hamburg (1790). Each of these houses is of central-chimney plan, with the chimney divided on the first floor so that a fireplace occurs in each front room. By means of a barrel vault at the height of the first-floor ceiling, the two flues were brought together, and from that point continued upward as a single stack. (Figure 78.) In the Tuttle house, this space in the chimney was occupied by the stairs to the second floor.

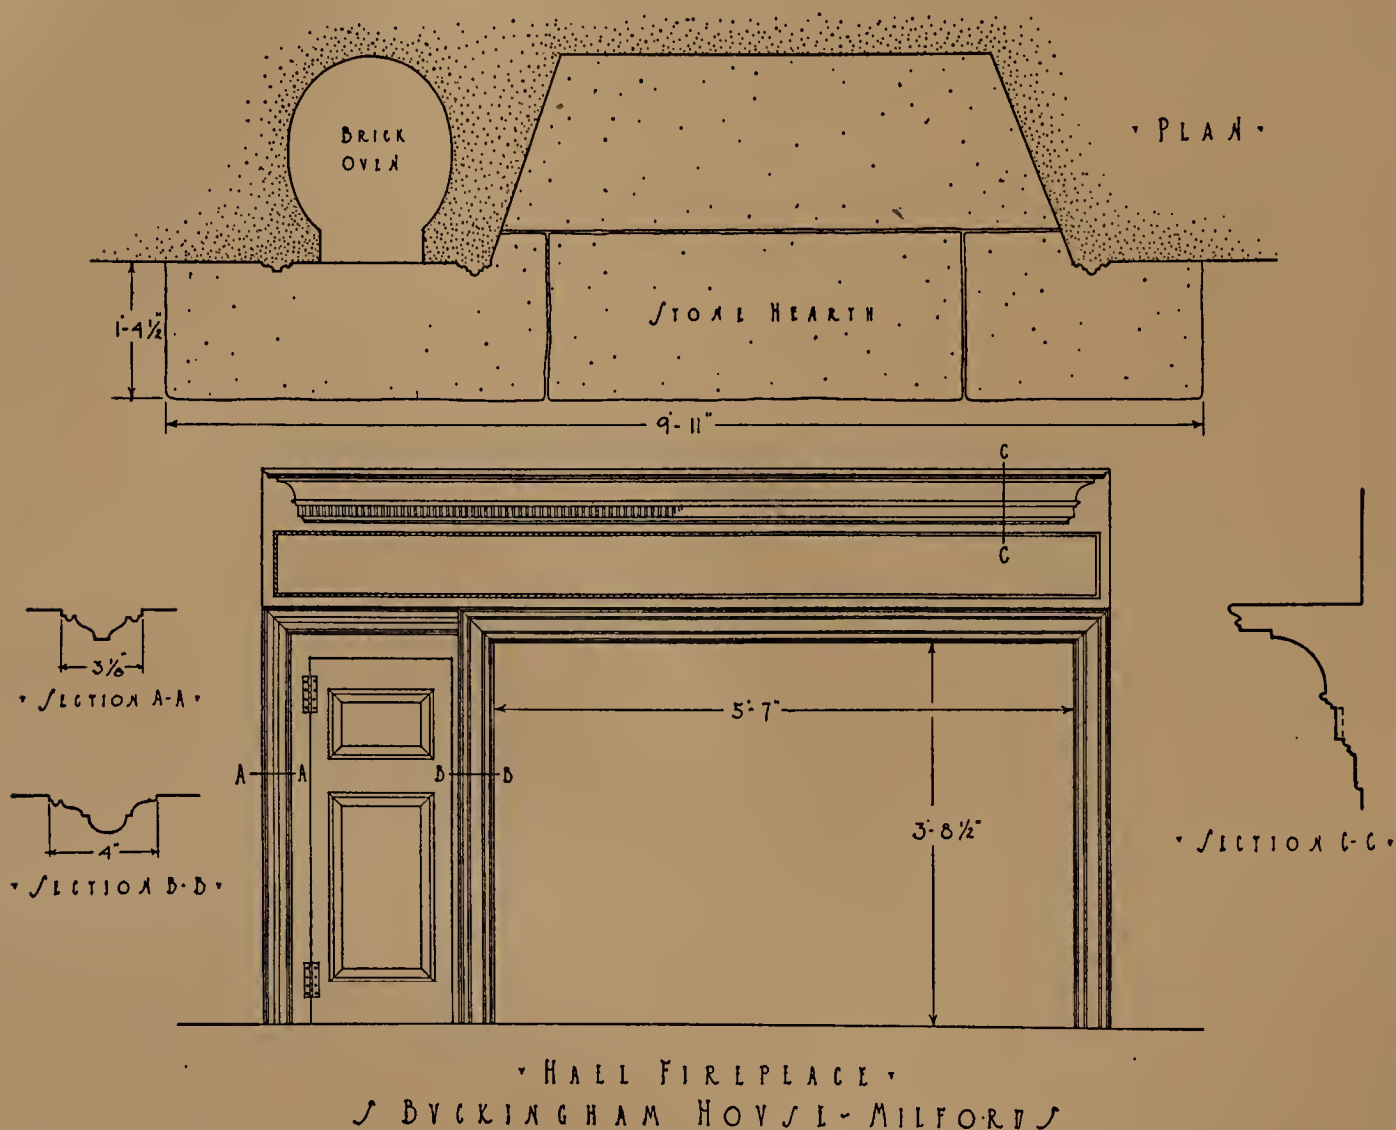
FIGURE 79.

Mantels of this type are commonly to be found in the kitchen or the old hall, especially in a house of the lean-to period. (Figure 79.)

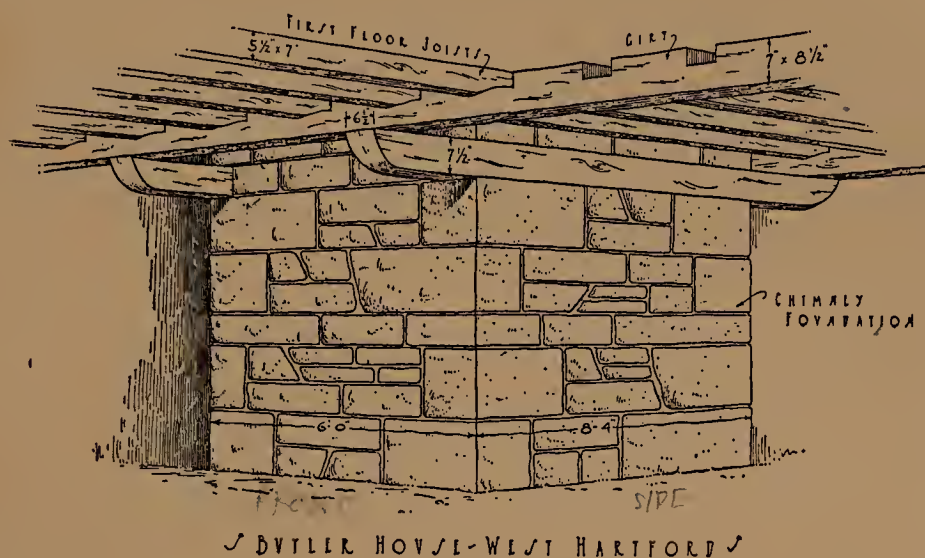
FIGURE 80.

The front and back hearths were most often of flat stone slabs, one piece serving for each. The front hearth, which finished level with the wood floor, is always of greater width on the first than on the second floor—a fact explained by the support afforded the first-floor hearth by the foundations of the chimney in the cellar below. It was customary to corbel or build out the base of the chimney stack in order not only to carry the hearthstones of the first floor, but also to provide a support for the cellar chimney girts. *Fig 80.*

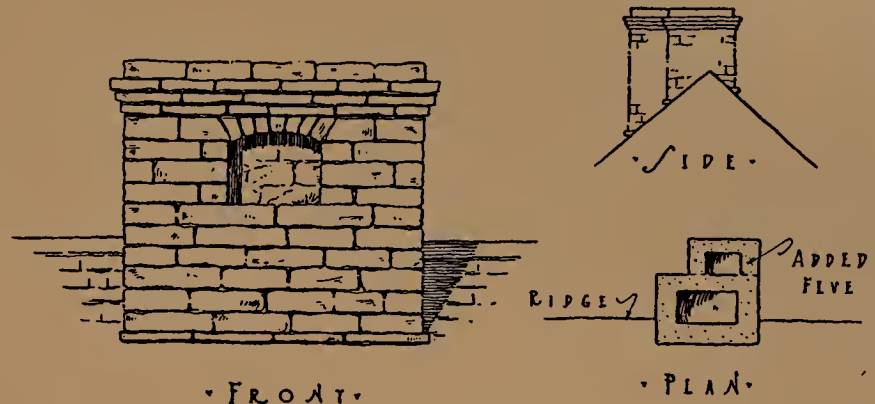
FIGURE 82.

The chimney top of the General Walker house in Stratford, built about 1740, is shown in Figure 82. A recessed niche about 18 inches square and three or four inches deep was built

When the original house was of two-room plan and a lean-to containing a kitchen was added, a new flue was made necessary. Such additions to the chimney stack are always easily traced, especially as the work was often very clumsily done. The chimney, where it appeared above the roof, became L- or T-shaped in plan—one of the surest indications that the lean-to, where it exists, was a later addition. (Figure 82.)

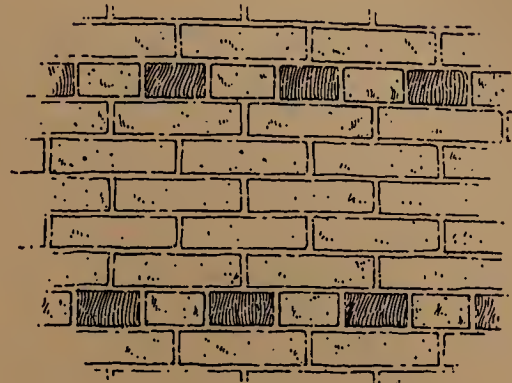
• BOND IN BRICK WALL •  
 / "ELM FORT" - SUFFIELD /  
 FIGURE 83.

of which the old mill house or "Elm Fort" at Suffield are built measure 2 by 4 by 8 inches. Every sixth course is made up of headers, of which every alternate brick is a black or semi-vitrified brick from the arch of the kiln. (Figure 83.) Brick used for filling between the studs of the exterior walls of the Isaac North house, Berlin (*circa* 1735), are  $2\frac{1}{2}$  by  $4\frac{1}{4}$  by  $8\frac{1}{2}$  inches in size. They are laid on edge, in clay mortar. Brick which were similarly used in the Deacon Tuttle house, in West Hartford (*circa* 1700), measure  $2\frac{3}{8}$  by  $4\frac{1}{4}$  by  $8\frac{3}{8}$  inches. (Figure 84.) The dimensions of a brick from the Moulthrop house in East Haven (*circa* 1690) are  $1\frac{5}{8}$  by  $2\frac{7}{8}$  by  $6\frac{1}{2}$  inches. Brick used in the construction of the Samuel Webster house in East Windsor Hill (1787) are of two sizes, one 2 by  $3\frac{7}{8}$  by  $7\frac{3}{4}$  inches, the other  $2\frac{1}{2}$  by  $4\frac{3}{8}$  by  $10\frac{1}{2}$  inches.

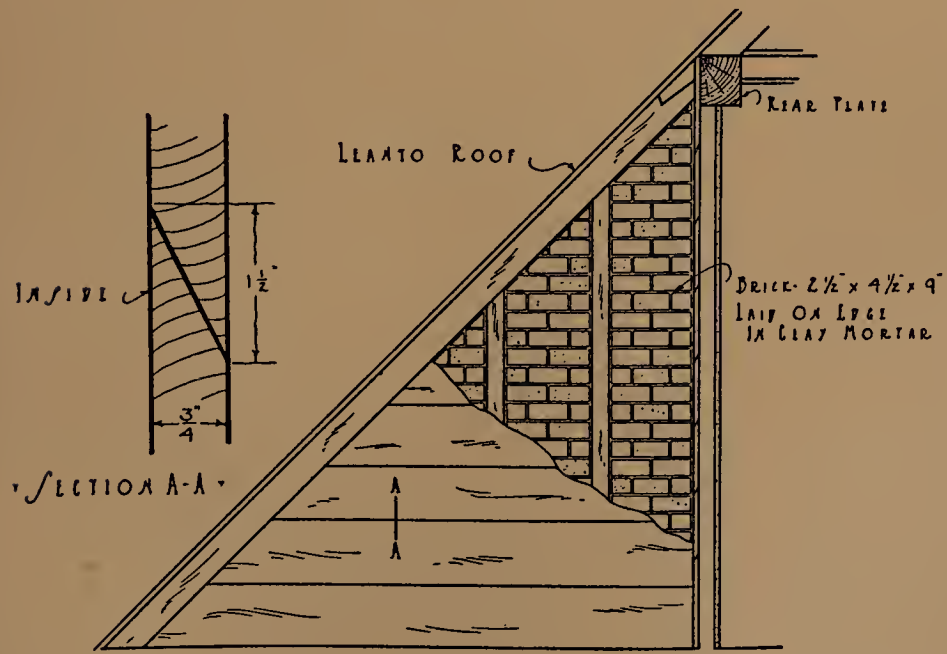
/ TUTTLE HOUSE - WEST HARTFORD /  
 FIGURE 84.

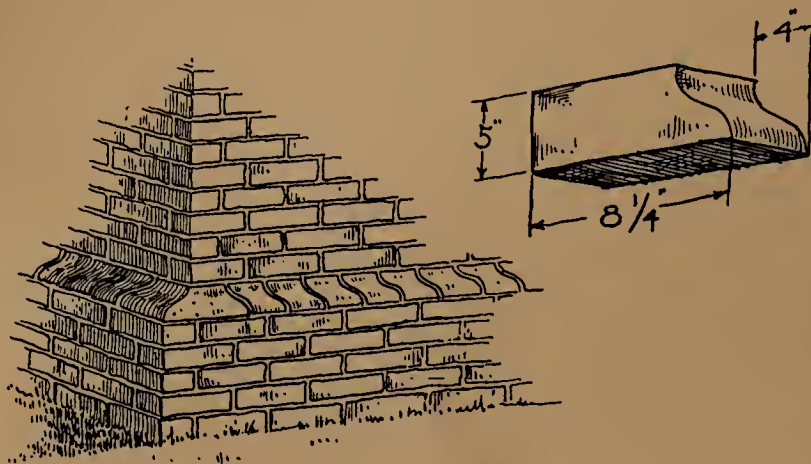
FIGURE 85.

Another noteworthy feature in connection with brickwork is the use of a moulded course of brick in order to give a pleasing line to the offset of four inches which usually occurred between the underpinning and the walls of the first story. (Figure 85.) Brick of this sort are to be seen in the base course of the building known as "Old South Mid-

de," on the Yale Campus in New Haven. The contour of such brick, which were especially moulded for this purpose, is a reverse curve, very pleasing.

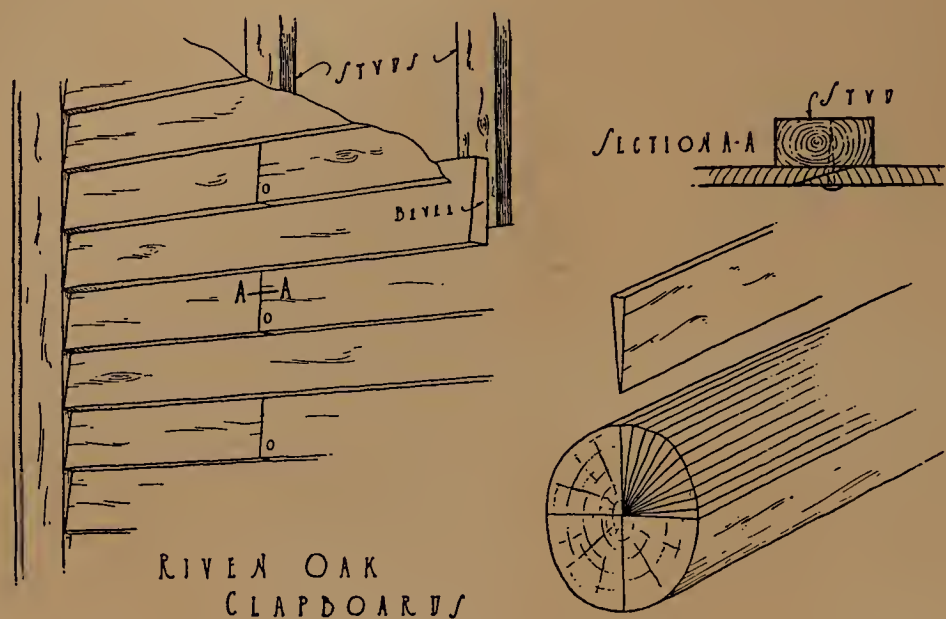
FIGURE 86.

Such clapboards of riven oak were, almost without exception, nailed directly to the studs, and the ends, which necessarily met upon a vertical stud, were bevelled and lapped in order to make the joint more nearly weatherproof. (Figure 86.)

In width the early oak clapboards varied considerably, different specimens measuring from  $4\frac{3}{4}$  to  $8\frac{1}{2}$  inches. The commonest width appears to have been about five inches, and the "weather," or exposed surface, about four inches; so that the lap was about an inch. Wider specimens were of course laid with a greater exposure to the weather.

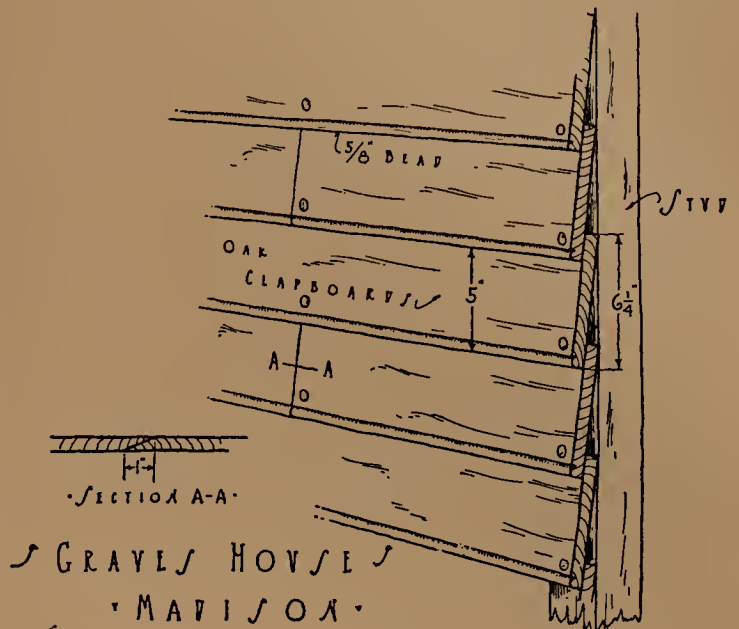
FIGURE 87.

A somewhat later form of oak clapboard than the riven sort is shown in Figure 87.

Clapboards of this variety were more regular in form, for instead of being split they were sawn out and in addition planed on the outside, the lower edge being finished with a one-half- or five-eighths-inch bead. Like riven clapboards, they were applied directly to the studs, and the butts lapped. Similar clapboards, said to be the original covering, are still in place on the exterior walls of the Thomas Buckingham house in Milford, for which the date of 1639 is claimed.

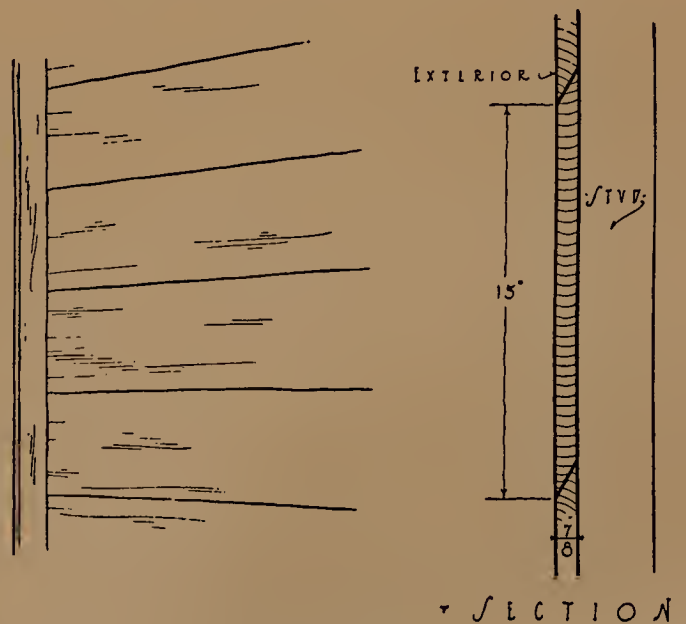
FIGURE 88.

There are also to be found in certain regions, as a covering of very old houses, broad boards of white pine, three-fourths or seven-eighths of an inch in thickness, applied directly to the studs. The horizontal edges of such boarding have bevelled joints, so that the outside finish is flush. (Figure 88.) The Hurd house, in Moodus (1760) (Plate XVI), is completely covered with boarding of this variety. In the lean-to attic of the Loomis house in Windsor (1688), bevel-edged boards of width varying from 12 to 15 inches may still be seen covering the rear wall of the original main house.

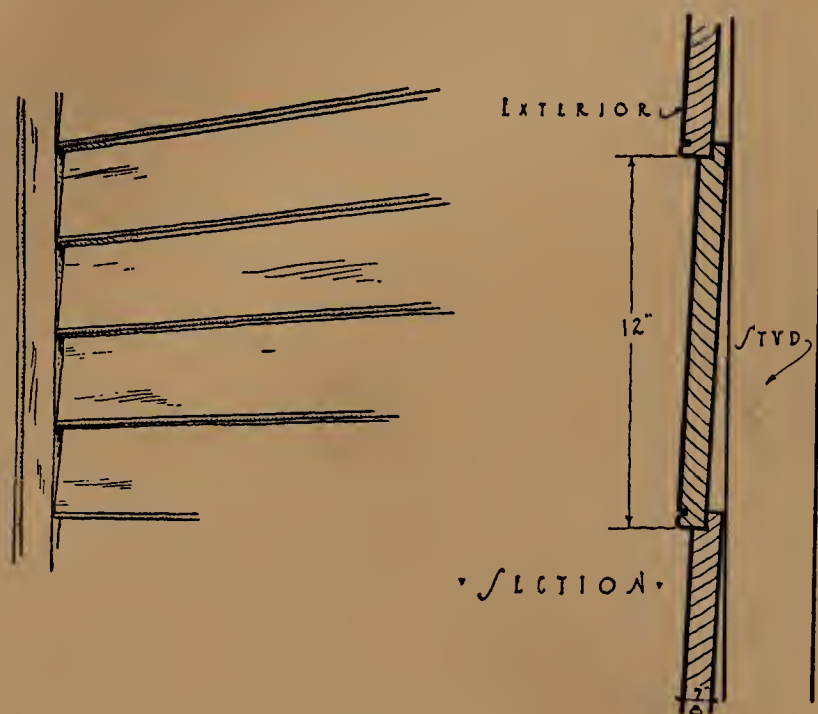
FIGURE 89.

A far commoner form of outside covering, not peculiar to any particular period, is that generally known as "weather-boarding." From Figure 89 it will be seen that weather boarding consisted of wide boards of white pine, usually about a foot in width and seven-eighths of an inch in thickness, applied to the studs in horizontal courses. The lower edge of each course, which in late work was beaded, was set into a rabbet cut in the upper edge of the course below it. "Weather boarding," as the old records have it, was sawn out, and its exposed surface planed as well. It was never so commonly used as clapboards. It often occurs on the ends and rear walls of houses, the fronts of which were clapboarded. The Bradley-Tyler house in East Haven (*circa* 1745) and the Tyler-Palmer house in Branford (*circa* 1710) are examples of this treatment. In general, weather-boarding is characteristic of late work. In such

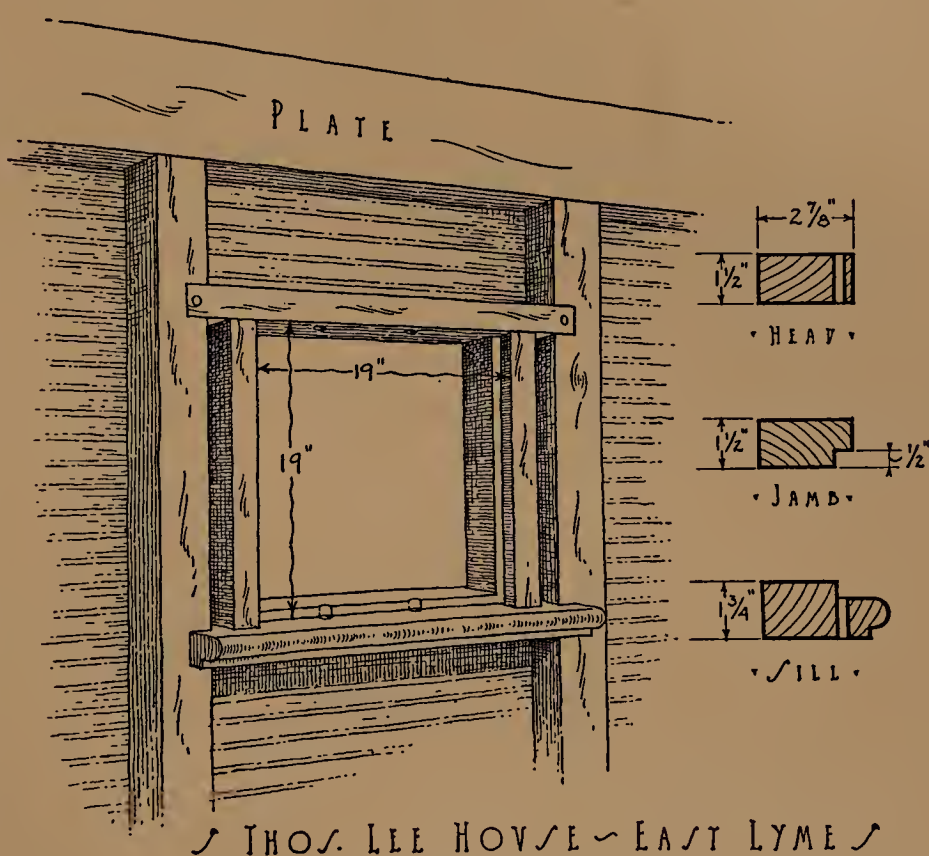
FIGURE 91.

Two seventeenth-century window frames, *in situ*, enable us to get a good idea of the general type of window in use prior to 1700. One of them may be seen in the lean-to attic of the Thomas Lee house in East Lyme (1664), in what at present appears to be the rear wall of the original house. But this house, as first built, faced opposite to its present direction—the orientation of the house was changed when the lean-to was added—so that this window frame is really in the front wall of the original house. It is in the second story, just below the plate. (Figure 91.) The frame, from which the casement sash is missing, is entirely of oak. The vertical jambs on either side are tenoned into the head and sill respectively. The frame is secured in place in the customary manner, by mor-

tising the projecting ends of the head and sill into the studs on either side. A rabbet on the outside of the frame, one-half of an inch in width, indicates the presence of sash originally. This rabbet, however, is to be found only on the sills and jambs, the head being plain. The interior edge of the frame is slightly moulded. The sash opening is small, measuring nineteen inches in each dimension; and the sill is four feet above the present floor. The purpose

of the four holes, two of which are in the head and two in the sill, is uncertain. This window frame is an extremely rare specimen, and the oldest which has so far been discovered in the state.

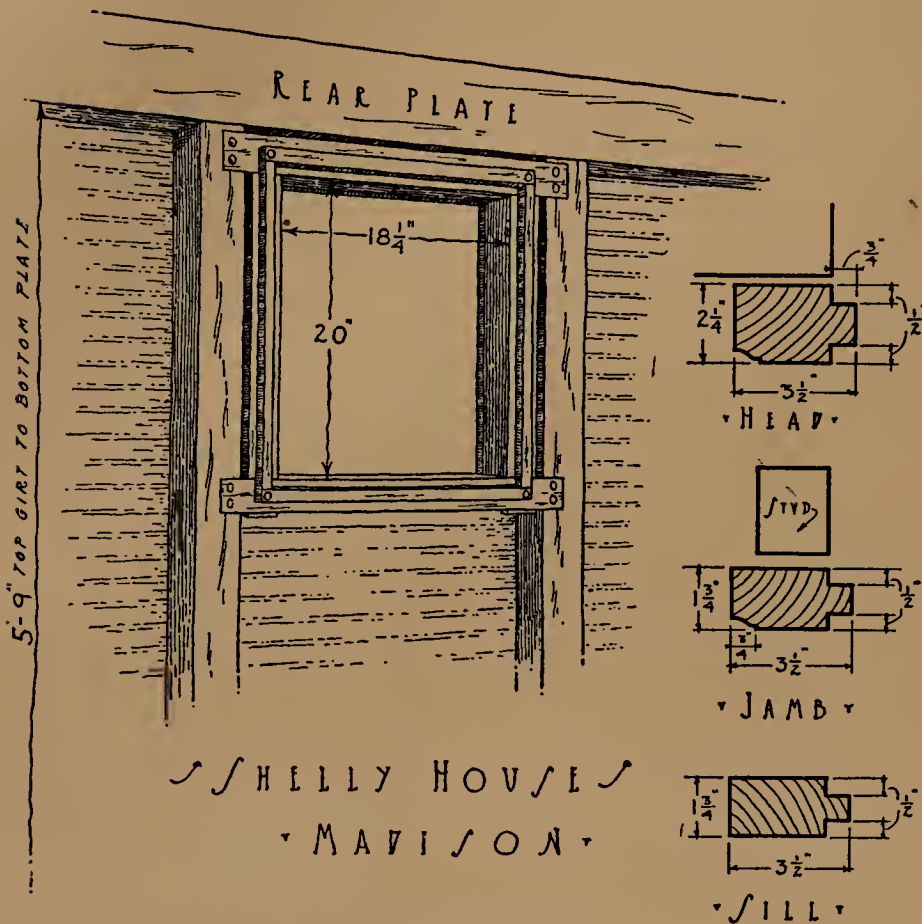
FIGURE 92.

The second example is somewhat similar. It is to be seen in the rear of the original house wall, in the attic of the added lean-to of the Shelley house in the town of Madison. The date of building of this house is uncertain; but it probably antedates 1700. The general construction of this frame, as may be seen from Figure 92, is the same as that in the Thomas Lee house. The section of the jamb, head, and sill, however, are somewhat different.

ent. A rabbet one-half of an inch wide on the outside of the frame shows that a casement sash originally filled the opening, which is  $18\frac{1}{4}$  inches wide by 20 inches in height. The frame, as may be seen, is set snugly beneath the rear plate.

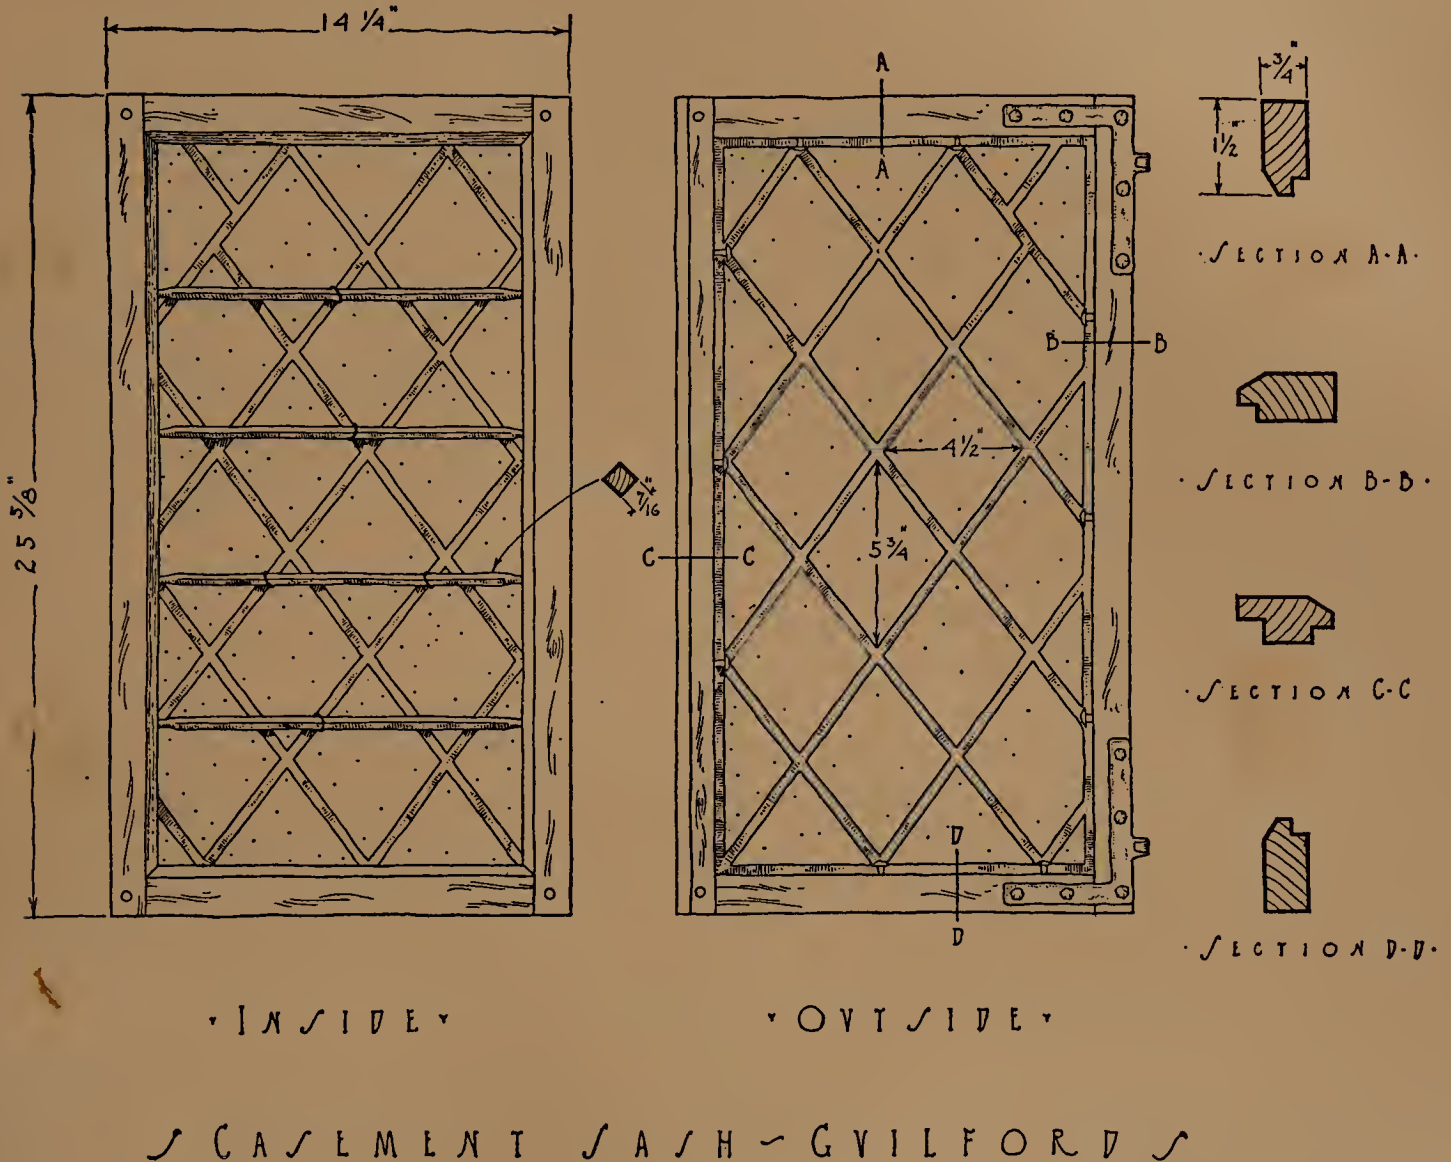
FIGURE 93.

A typical example of casement sash, such as was probably used in both of the window frames under discussion, is shown in Figure 93. It is at present in the Hyland-Wildman house in Guilford. From the illustration it may be seen that this sash is very thin—only three-fourths of an inch in thickness. The glazing is typical of the period, being composed of diamond-shaped lights or “quarrels,” the long axes of which are set vertically. They are held together by lead bars or “calmes,” slightly oval in section. The glass is extremely thin, being but one-sixteenth of an inch thick.

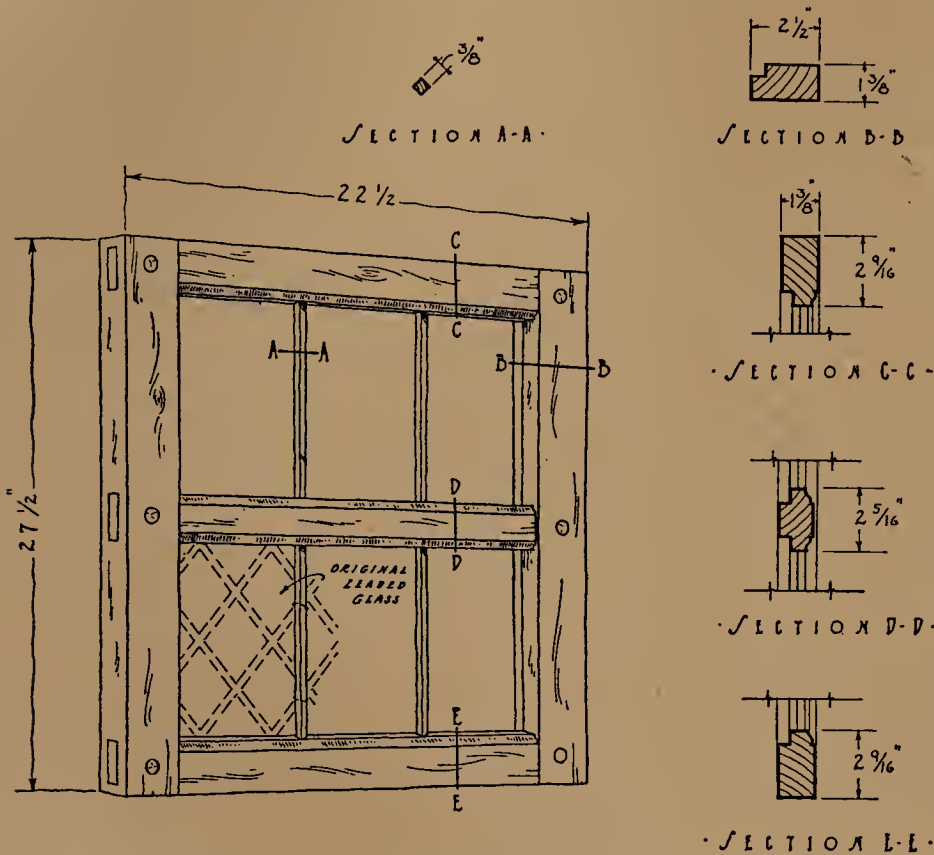
DOUBLE HUNG SASH - GUILFORD
